LIFE17 NAT/IT/00619 GREENCHANGE

Green infrastructures for increasing biodiversity in Agro Pontino and Maltese rural areas

DELIVERABLE C1.

GUIDELINES FOR THE ECOLOGIC MANAGEMENT OF RUBBLE WALLS AND TREE BELTS

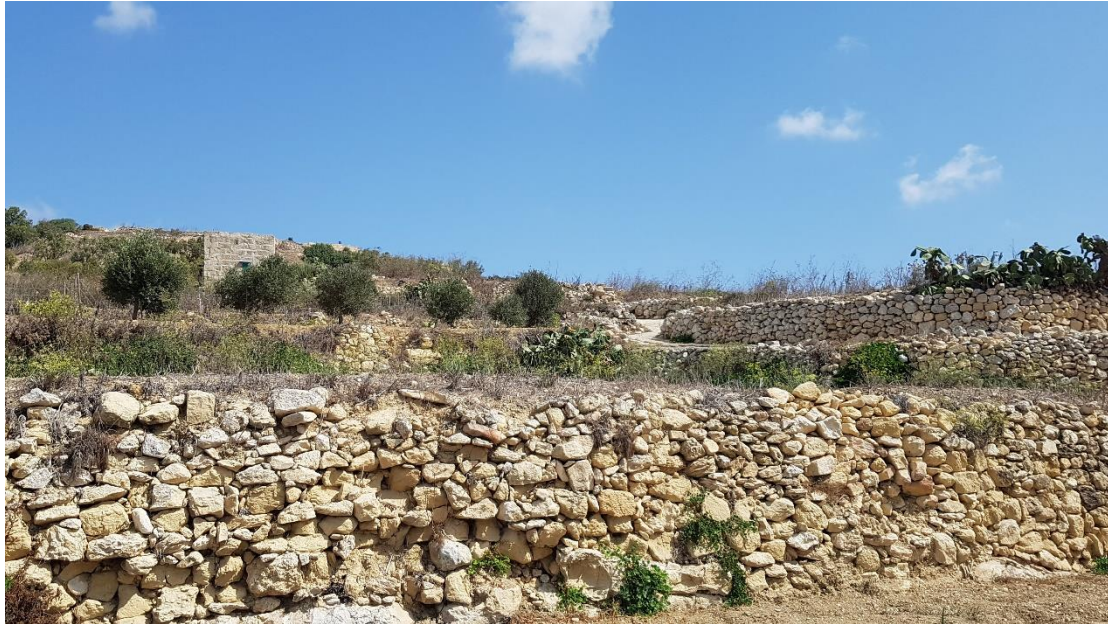
Taking into account that in a rubble wall stones must behave as if they formed a single block, during construction, the stones must be placed in such a way that they are in contact with each other as much as possible, carefully filling most of the hollow spaces with small-sized material (the so-called "flakes")

placed piece by piece. By doing so, a stable balance will be obtained due to the weight of the stones themselves and to the action of the forces that stress them.
